Briar Vale Flood Prevention Scheme – Discharge of Conditions - 19/00306/COND

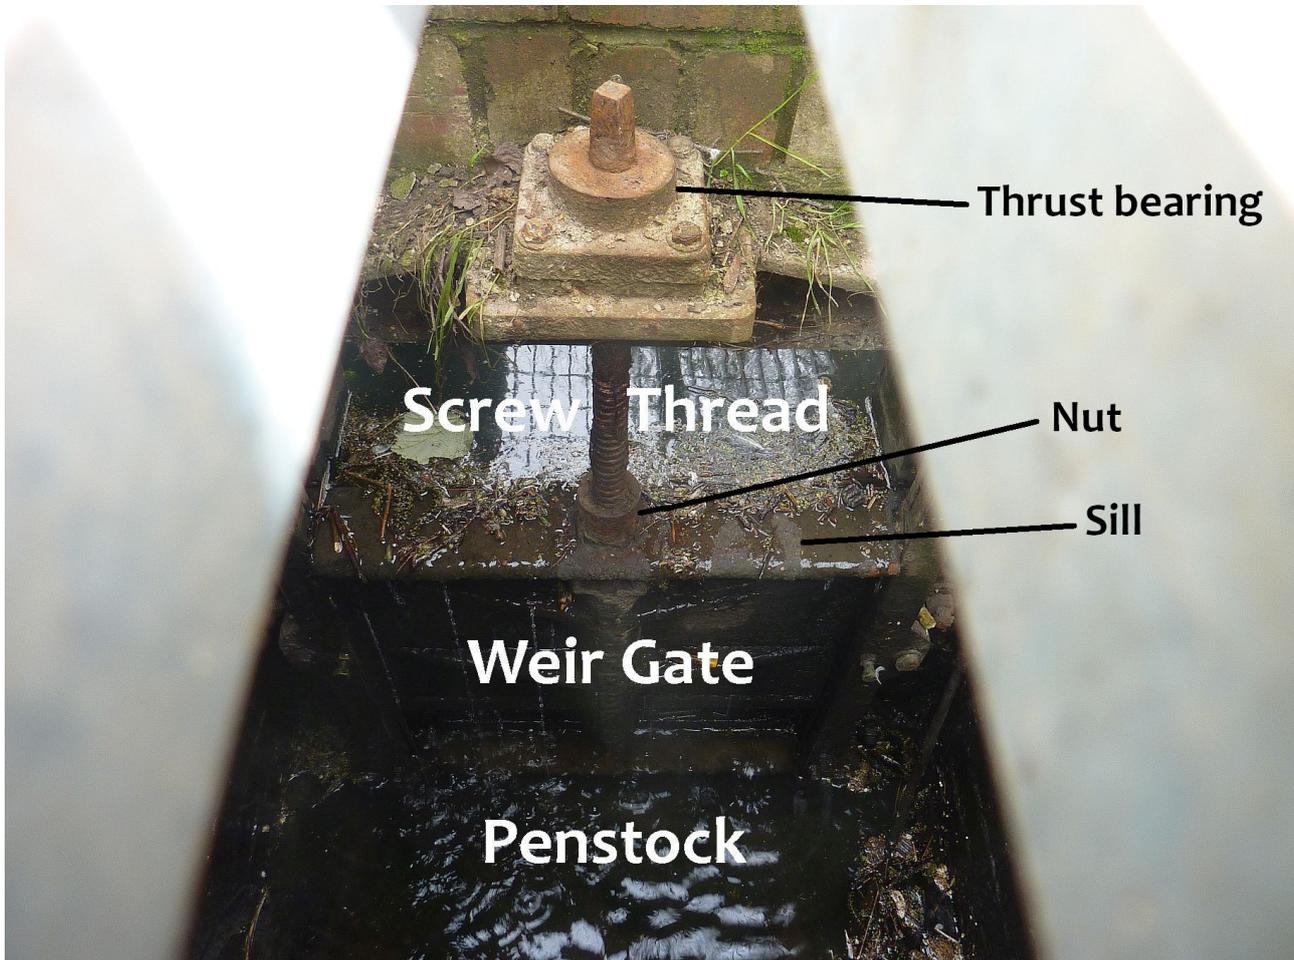
Contrary to Mr Lillie’s statement, the “adjustable penstock weir “ has remained jammed since Owen Pugh raised it by some 5cm and were unable to return it to the ‘as found’ position. The in-operability of the sluice gate has been confirmed most recently on 5 April, 2019 when workers from NWL attempted to move it (under a request from the NTC project engineer, Mr Burnett).

The photograph of the weir gate above has previously been forwarded to Mr Burnett with some ideas for a way to effect a repair.

4. Repair and maintain the weir gate #. The maintenance should include regular raising/lowering over its full range to ensure it can be opened in the event of an impending storm in the lake’s catchment area. # - or replace it.

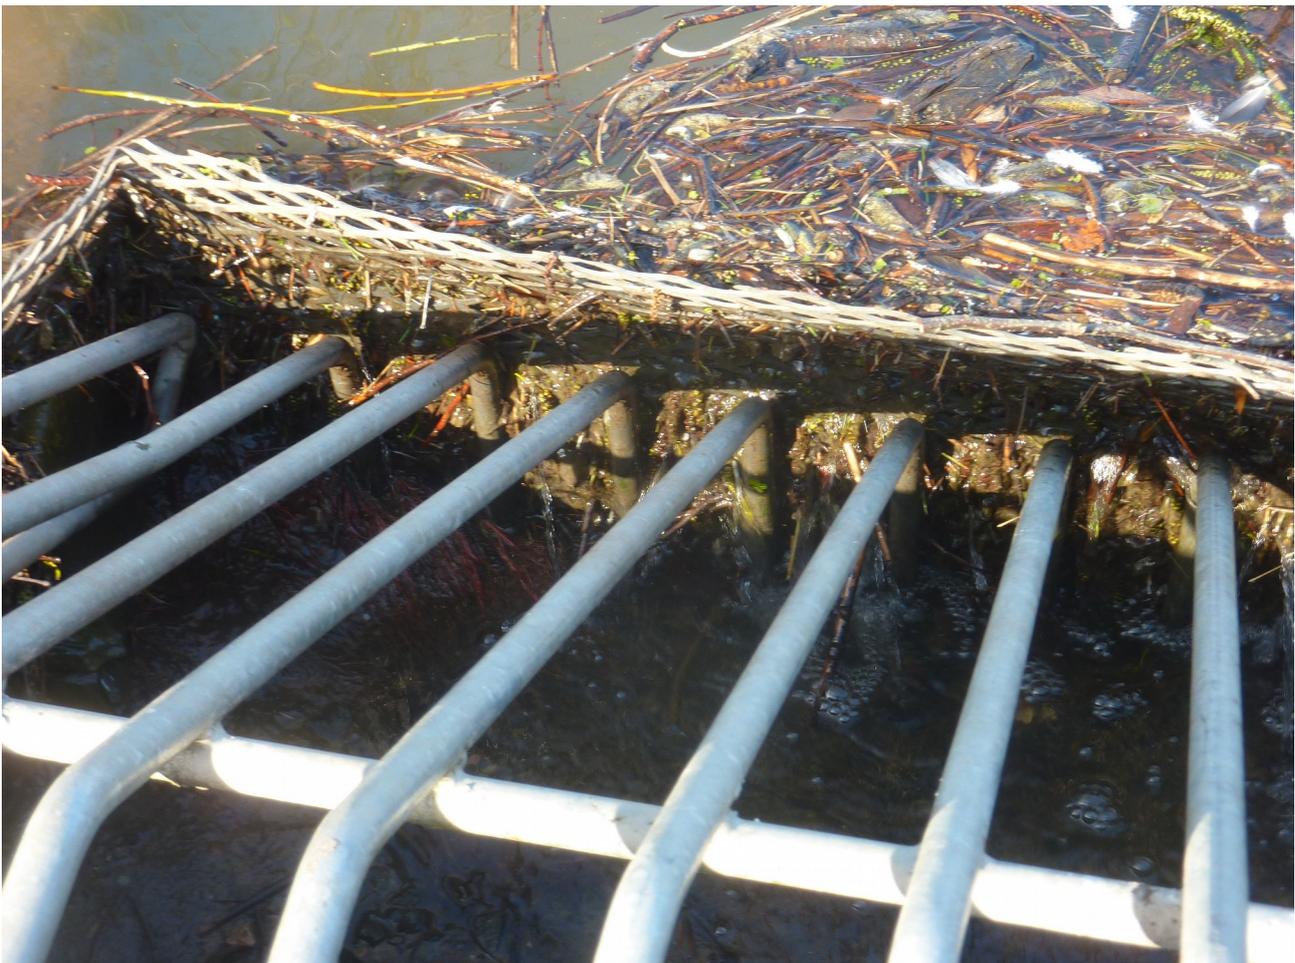
Photo taken 18 March, 2019

Without the capability to easily open the weir gate it is not possible to maintain the lake level to avoid flooding of the surrounding area as continues to happen with or without the additional flow from the Briar Vale storage basin. The regular blockage of the wire mesh over the external grille on the lakeside of chamber 1 causes a drop in water level to the inside of the grille. This has been estimated as typically 10cm – 12cm. A long establish formula for flow over a weir reveals that the flow rate varies with the depth of the water above the sill to the power of 1.5. Thus, the flow rate for a depth of 6cm compared with 1cm is 15 times as much. This explains why the lake level drops so slowly compared as to how it was before the weir gate was jammed in the position left by the Owen Pugh work.

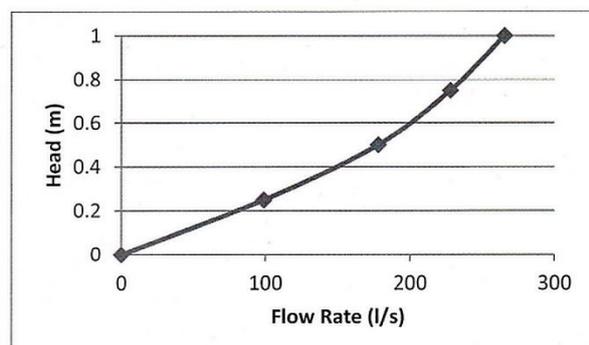
NWL provided the graph above in response to the question about the outlet flow rate from the lake after its re-direction to the North Sea. **It ignores any blockage of the outlet** and clearly assumes that the water level within the two outlet chambers is the same as that on the lakeside of the grill. (It ignores the position of the weir gate or assumes it to be lower than the invert of the notch in chamber 1.) **It takes no account of any drop in water level through the wire mesh and over the weir gate.**
